**The MacFarlan House:
A Survey of an Okie-Designed Work in Progress**

Rebecca Angeline Geist

A THESIS

Historic Preservation

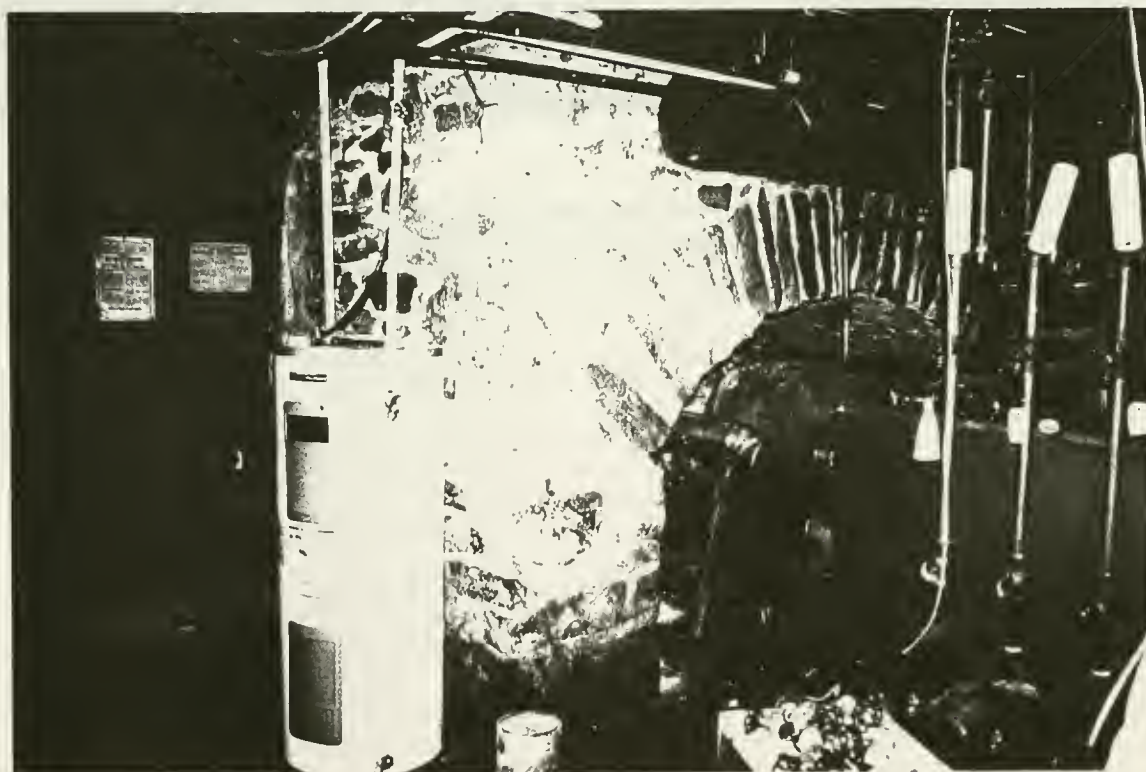
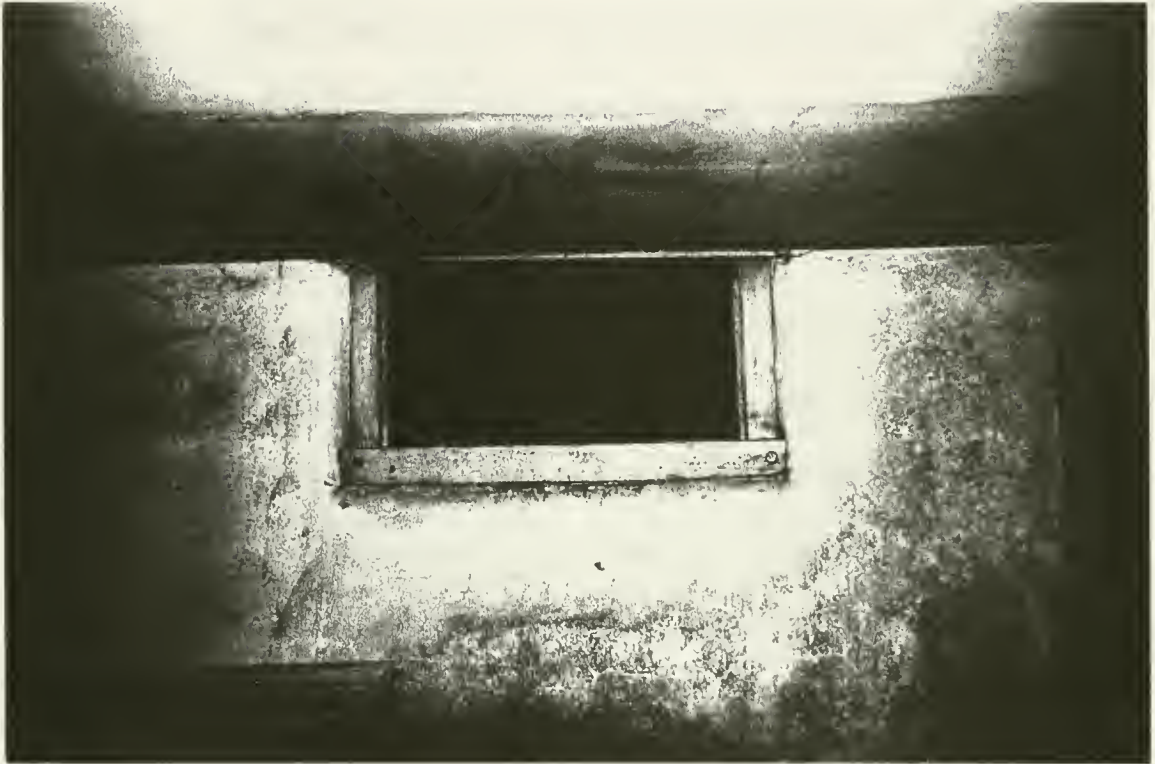
Figure 2.1d The lower half of an exterior window is located in the attic wall between the eastern and western portions. Before the western portion was added, this window was facing outside. The roof collars, with attached ceiling, are now placed in front of the opening on the west side, though the window is fully apparent from the eastern section.

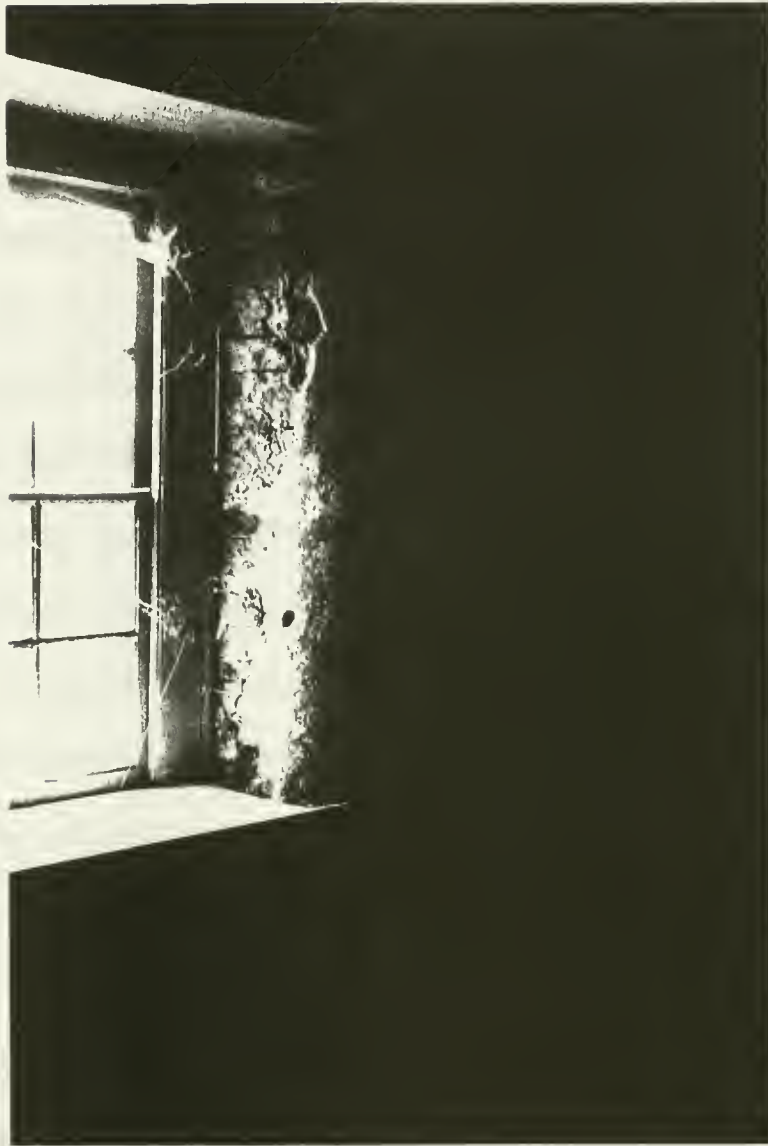
Figure 2.3f Curved window jamb openings are found throughout the western section of the house, upstairs and downstairs. They were also documented in the current dining room and the chamber above. These do not occur in the eastern section of the house where all the window jambs were right angles. This photograph was taken in Bedroom A, western section.

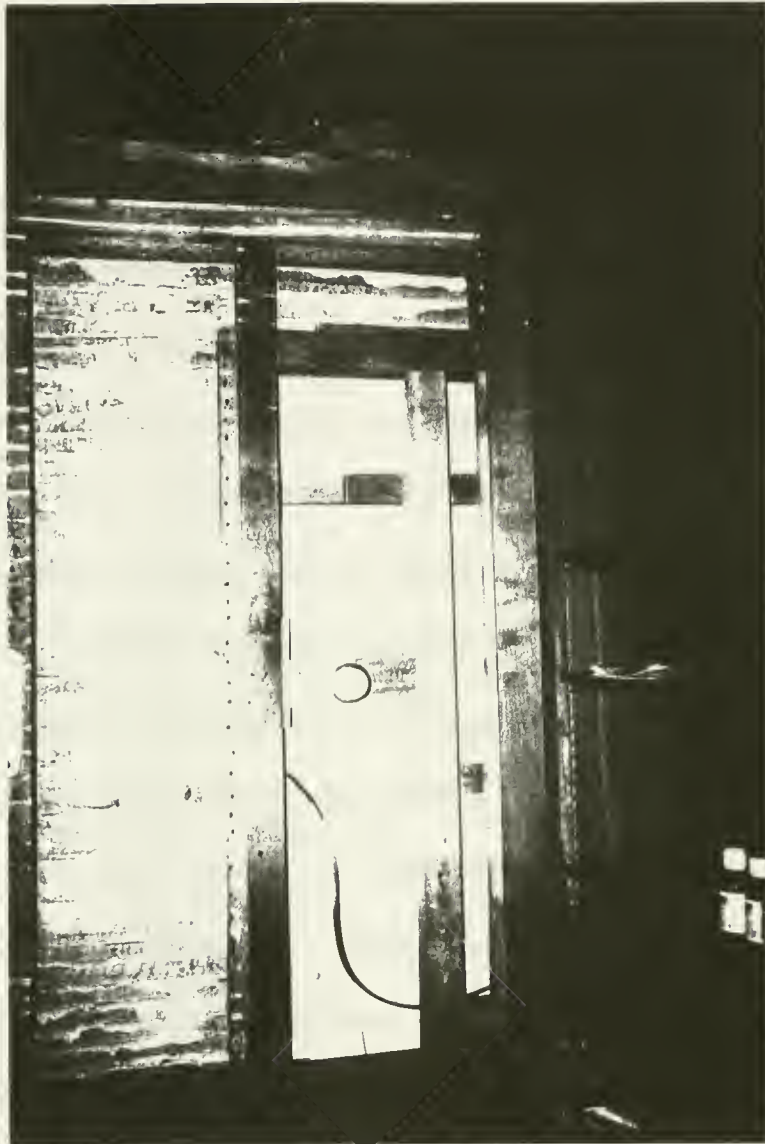
Figure 2.9b This is the partition wall between the two rooms of the ground floor, eastern section of the house. Here, framing for a once-existing door is apparent, covered on the opposing side with feather board. At the top of the photograph, the end of what were the exposed, beaded joists in the existing library can be seen. These joists were subsequently covered with lath and plaster during the construction campaign in which the renovation and addition of the western section of the house occurred. This photograph was taken in the study, south wall.

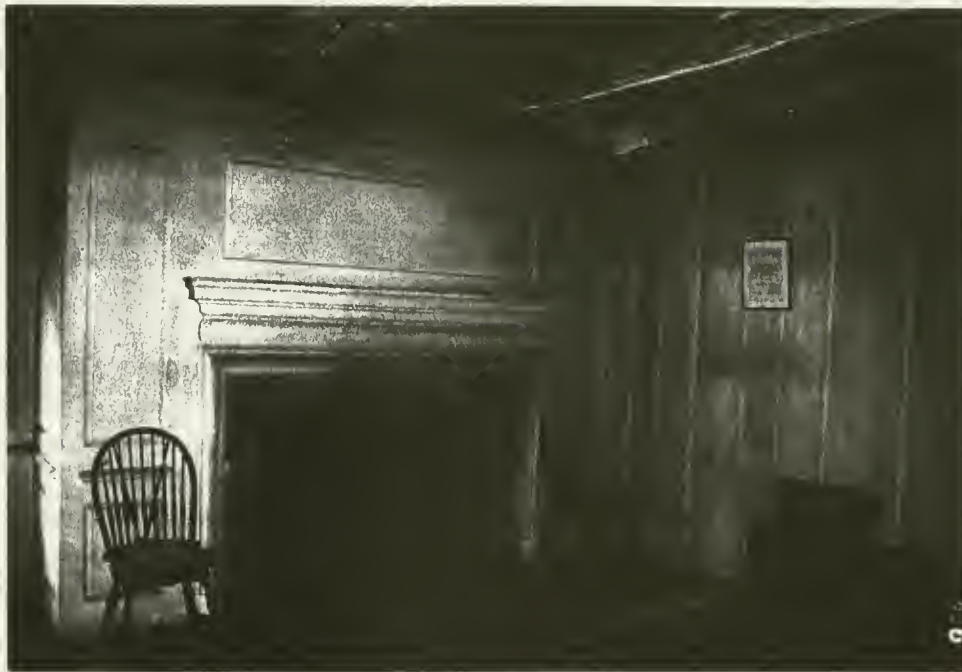
Figure 3.12c Photograph of the west elevation fireplace wall showing the corbelled stone protruding through the raised panel above the mantel to support the summer beam.

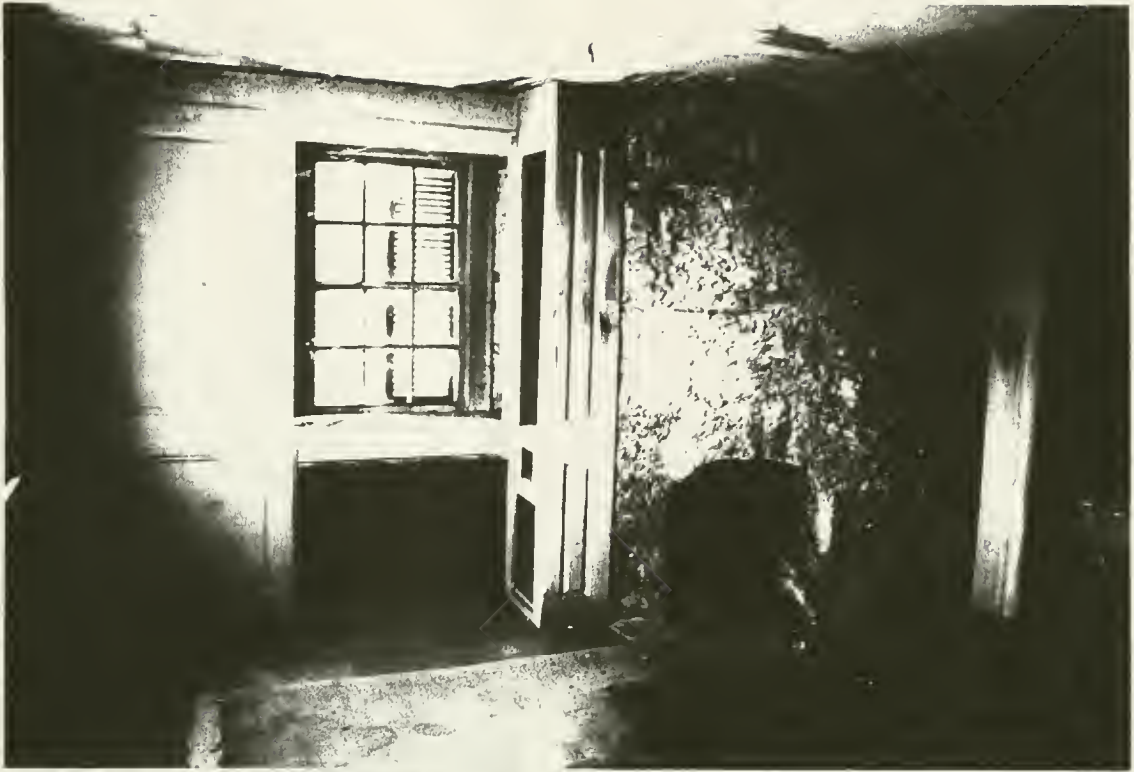
Figure 3.42a Bedroom A, West Elevation The west wall of this bedroom underwent many changes to the area left of the fireplace. A small gun cabinet with a drawer was constructed and never completed.

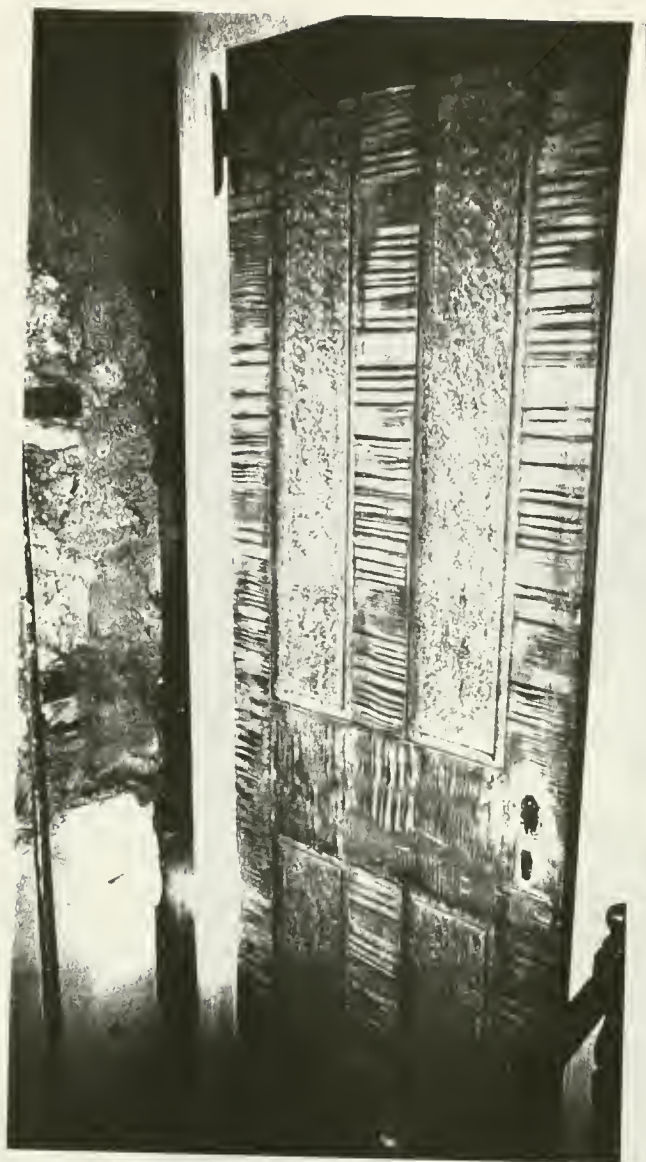
Figure 4.10 This photograph shows one of the pre-existing grained doors of the second floor which Okie chose to keep. Here, Okie has removed the butt hinges which were original to the door and applied H hinges.
